**BKV**  
GROUP

## Fulda Fire Department Study

Fulda, Minnesota

July 2, 2018

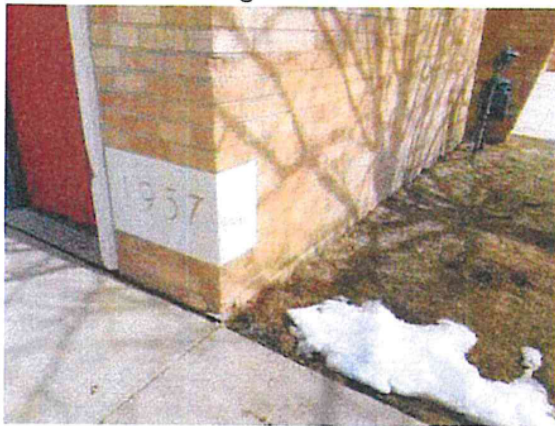
Figure A.1.1

1. Past and Current Use
  1. The Fire Station and City Hall was built in 1957. The apparatus bays were lengthened in the early 1980's to accommodate additional apparatus. The roof was replaced in 2008.
2. Size
  1. The building is approximately 5,400 square feet and 15 feet tall. The fire department has sole occupancy of approximately 3,350 square feet. The parcel is not subdivided from a full-block City park.

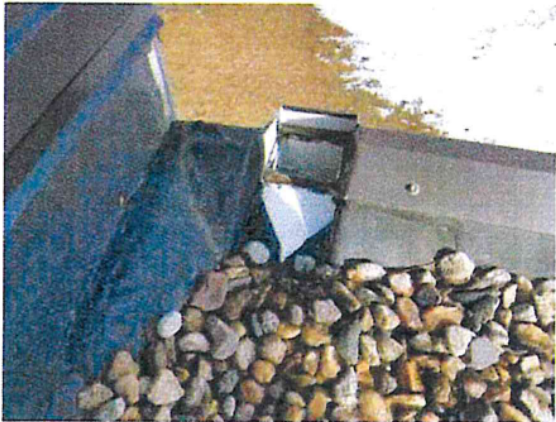
Figure B.2.1a

1. The canopy above the apparatus doors drains to an open-faced downspout and discharges at grade east of the building.
  2. The roof drain from the apparatus bay roof discharges at the east side of the building.
