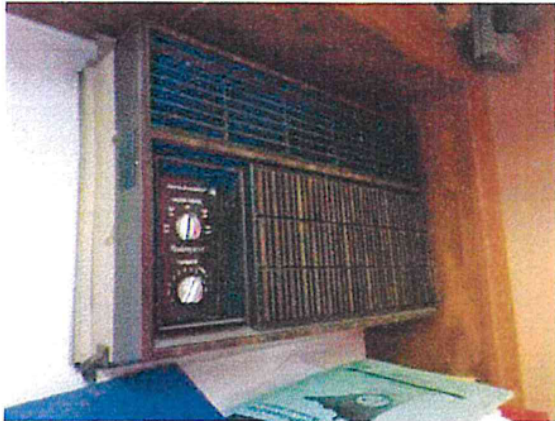
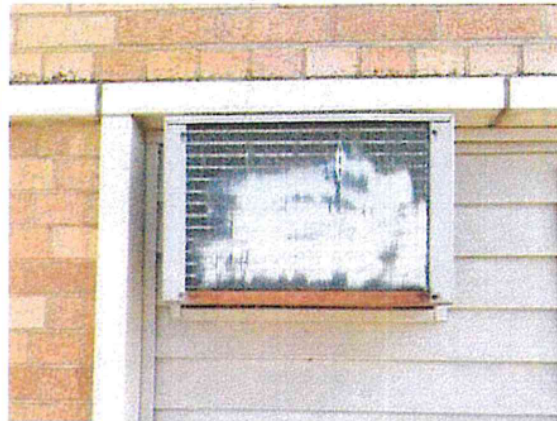
1. The window air conditioner in the Office is past its expected service life and the cooling fins are bent. It should be replaced.
2. There is no heating system in the Office, and heat is provided by a plug-in radiator-type space heater.
3. There are two boilers in the Boiler Room, which were installed in 2016.
4. The water-side unit heaters in the apparatus bay are past their expected service life but are in good condition.
  1. The thermostat is located on the west wall of the Apparatus Bays
5. No ventilation or exhaust systems are installed in the Apparatus Bay.

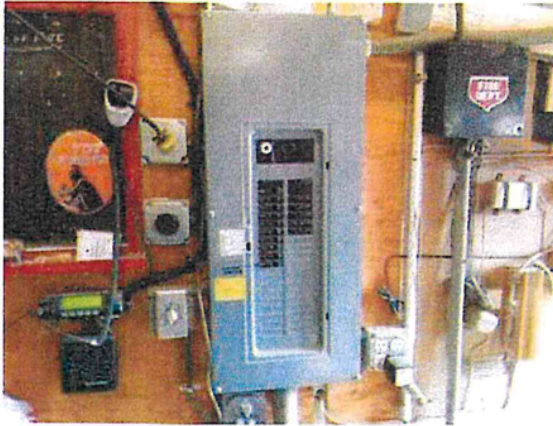
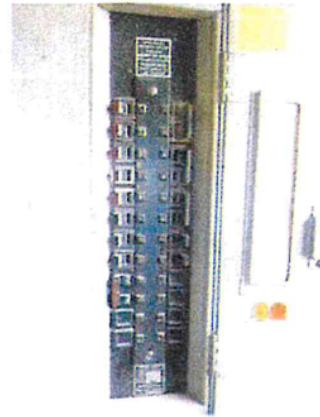
1. A 200 Amp single-phase main panel and 200 Amp sub panel are located at the southeast corner of the apparatus bays.
  1. The main panel is missing a door.
2. An additional sub-panel is located in the Boiler Room.
3. The electrical panel and all circuit breakers appear to be in good working condition.
4. There is a junction box in the Office without a cover plate.
5. Electrical shore lines at each apparatus are powered through 12V converters or car battery chargers.
6. Outlets in the Apparatus Bays appear to be without Ground Fault Interrupt

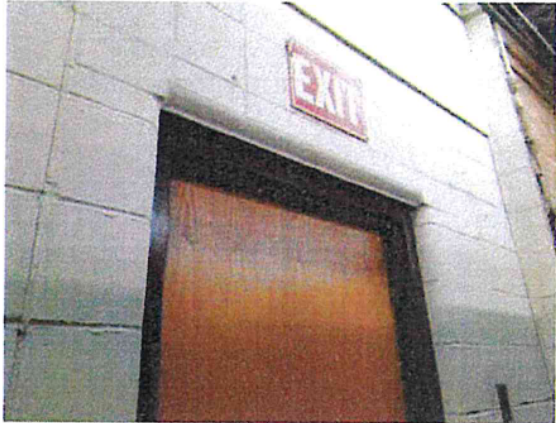
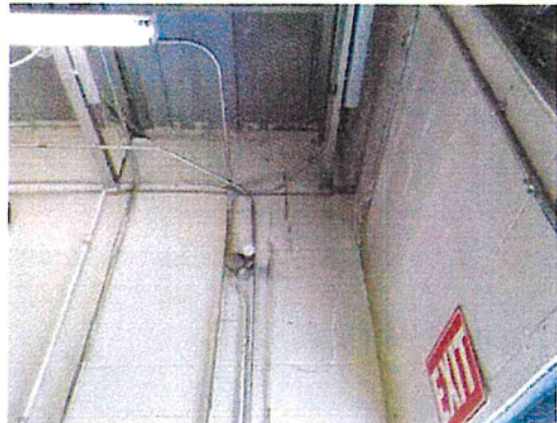
1. There is no exhaust system in the vehicle storage area.
2. There are no lighted exit signs from the apparatus bays.
3. There is a large hole in the wall between the Apparatus Bays and the Boiler Room with no fire damper.

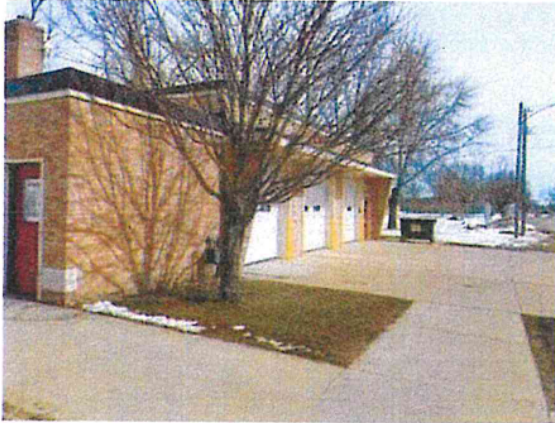
Figure O.1

1. There are no truncated dome detectable warnings where the apparatus apron crosses the sidewalk.
2. There are no truncated dome detectable warnings where the City Hall front sidewalk ends at the street.
3. Doors throughout the building have knob hardware instead of lever hardware.
4. There is a step between the Apparatus Bay floor and the Office.
5. There is a step between the Apparatus Bay floor and the City Hall lobby.

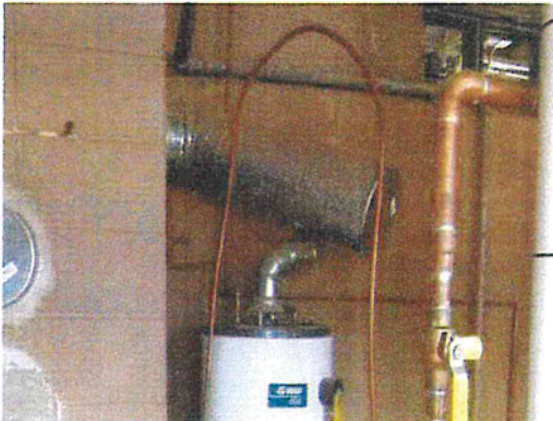
Figure P.2

1. The exterior walls are likely non-insulated.
2. Domestic hot water piping is not insulated.
3. Heating hot water piping is not insulated.
4. The apparatus doors are not well sealed against air infiltration.
5. Efficiency of the lighting system could be improved by retrofitting all fluorescent fixtures with LED lamps and adding occupancy and daylight sensors to appropriate spaces.
