# Fulda Fire Department Study

Fulda, Minnesota

July 2, 2018

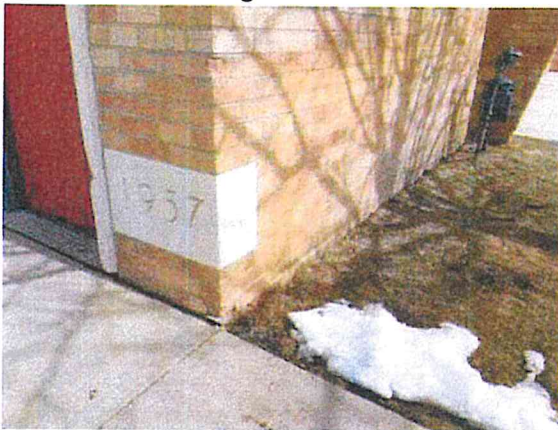
Figure A.1.1

1. The Fire Station and City Hall was built in 1957. The apparatus bays were lengthened in the early 1980's to accommodate additional apparatus. The roof was replaced in 2008.

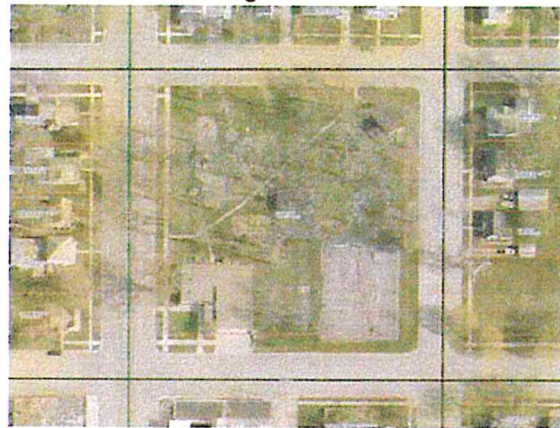
Figure A.2.1

1. The building is approximately 5,400 square feet and 15 feet tall. The fire department has sole occupancy of approximately 3,350 square feet. The parcel is not subdivided from a full-block City park.

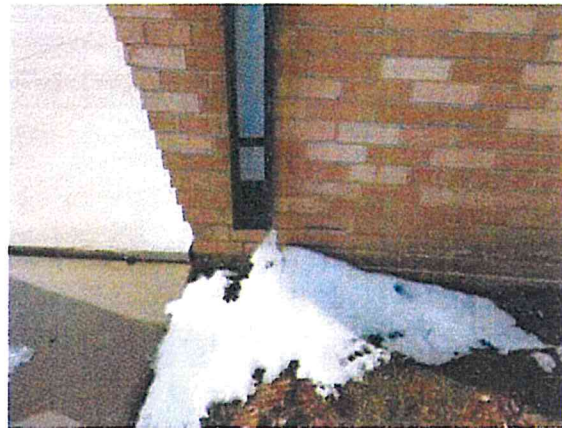
Figure B.2.1b

1. The canopy above the apparatus doors drains to an open-faced downspout and discharges at grade east of the building.
2. The roof drain from the apparatus bay roof discharges at the east side of the building.
3. The apparatus bay addition drains over the parapet into an open-faced downspout at the north side of the building
4. The roof above the office and boiler room is served by a single roof drain that discharges to the west of the apparatus bay doors along the apparatus apron.

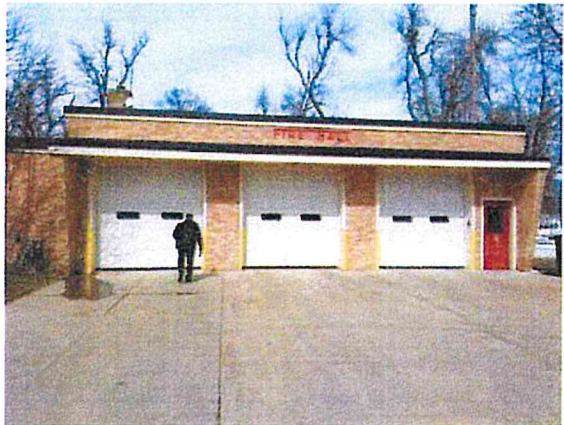
Figure B.3.2a

1. The asphalt paving in the 3rd Street right-of-way is in poor condition. We estimate that replacement will be necessary within five years.
2. The concrete apron is in good condition with minor cracking and limited cosmetic staining.
3. The concrete sidewalks are in good condition.

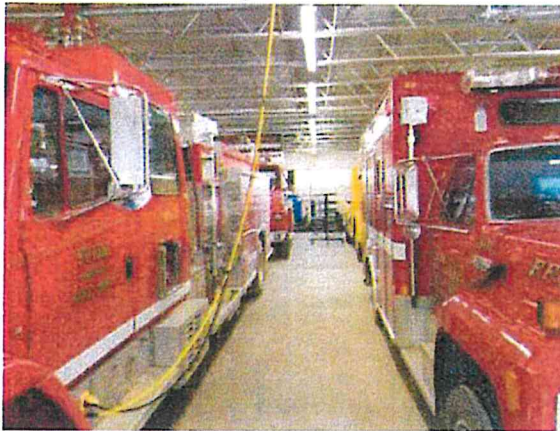
Figure C.2.1

1. Foundation
  1. The foundation appears to be in good condition as there is no evidence of building settlement.
2. Slab-on-grade
  1. Where visible, the slab appears to be in generally good condition.

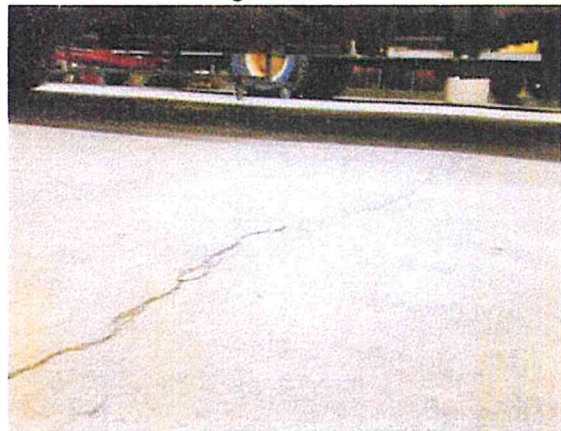
Figure C.2.1.1

- (1) There are minor cracks in the apparatus bay floor as is expected where there are no control joints.
    - (2) There is patching of the apparatus bay floor where the original office was removed during the apparatus bay expansion.

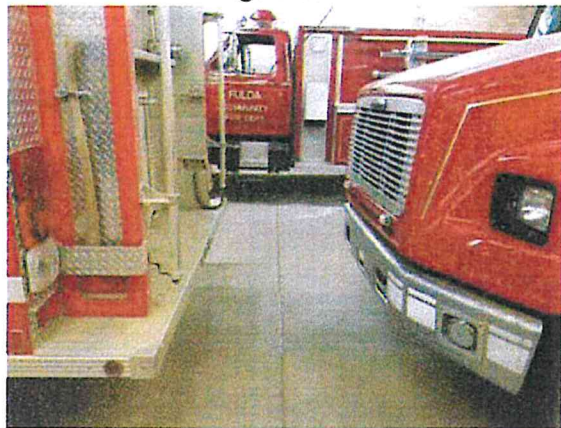
Figure C.2.2

2. The joint between the original Bay floor and the Bay Addition floor is in good condition.
3. Superstructure
  1. The exterior bearing walls are concrete masonry and are generally in good condition.

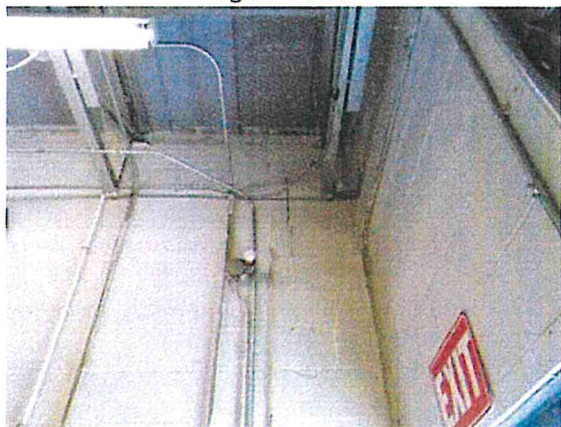
Figure C.3.1.2

- (1) There is continuous vertical cracking at the southeast corner of the Bays.
    - (2) There is continuous vertical cracking at the east side of the Bays.

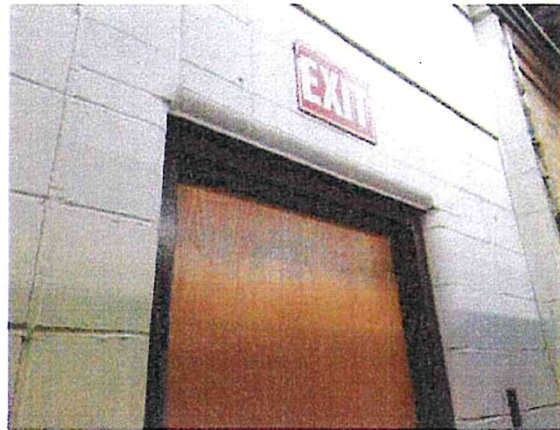
Figure C.3.2.2

- (2) There is continuous vertical cracking just south of the door connecting the Bays with the City Hall lobby.
  3. The original roof structure is cement decking over steel trusses and the 1980's addition roof structure is metal deck over steel trusses. All appears in generally good condition.

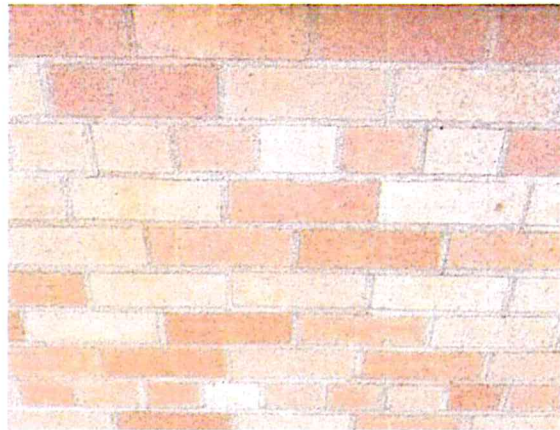
Figure D.1.1.1

1. The exterior walls are of standard brick and are in generally good condition.
  - (1) There are some locations along the west wall of the boiler room where the mortar has separated from the bricks. This should be tuckpointed.

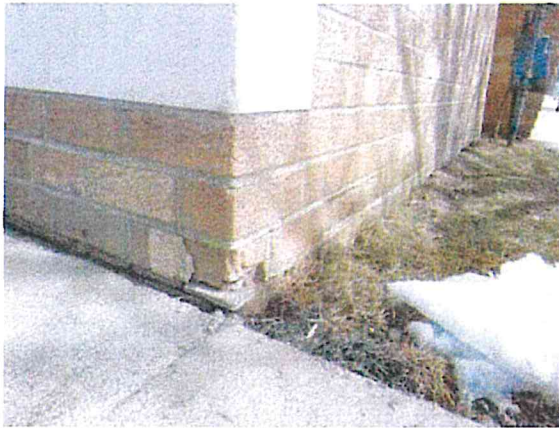
Figure D.1.1.2

- (2) The brick at the southwest corner of the office is spalled.
  - (3) There is no sealant at the base of the wall where it meets a concrete sidewalk.

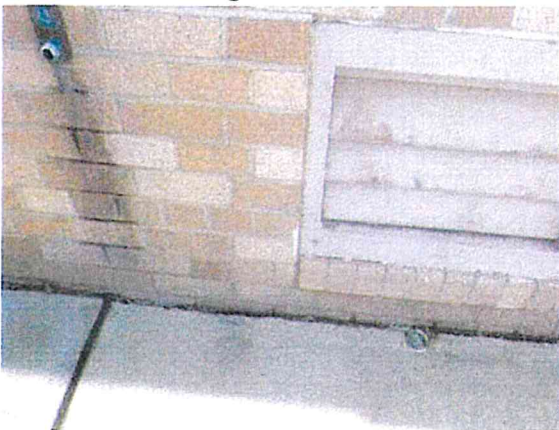
Figure D.1.1.4

- (4) There is no evidence of flashing at the base of the wall. The construction of the wall might be such that the flashing is not required, but it is typically installed as a best practice.

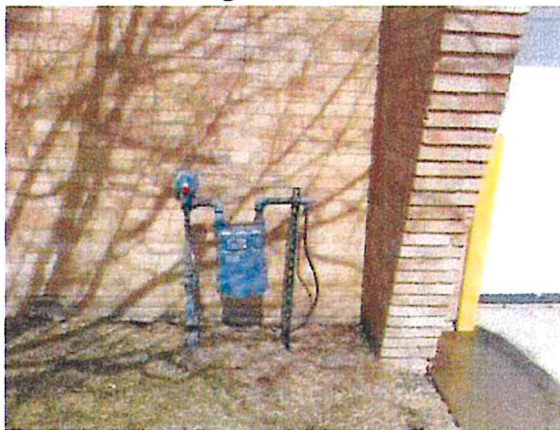
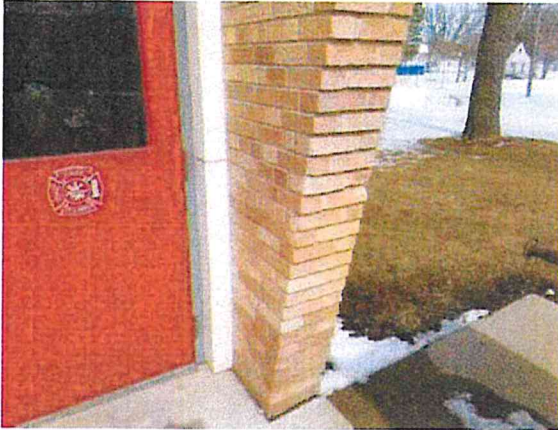
- (5) The corbelled brick at south wall is chipped and spalled in many locations.
  - (6) The brick at the base of the corbelled brick at the southeast corner is missing.

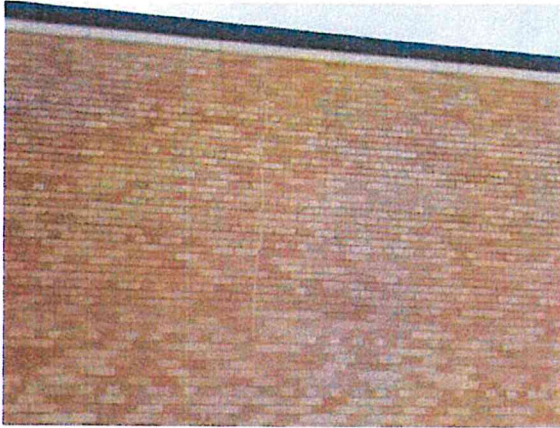
Figure D.1.1.7

- (7) There is a crack at the east wall that has been sealed. We anticipate that sealants will need to be replaced within five years.
  - (8) There are bricks at the northeast corner of the apparatus bays that are cracked or spalled and should be repaired.

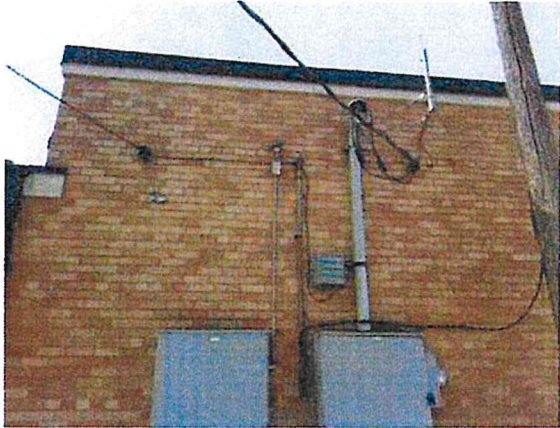
Figure D.1.3

3. The brick wall above the electrical service is stained. This is a cosmetic issue.
4. The infill walls clad in vinyl siding are in good condition.
5. The piping and conduit penetrations through the exterior wall are in generally good condition. We anticipate that sealants will need to be replaced within five years.

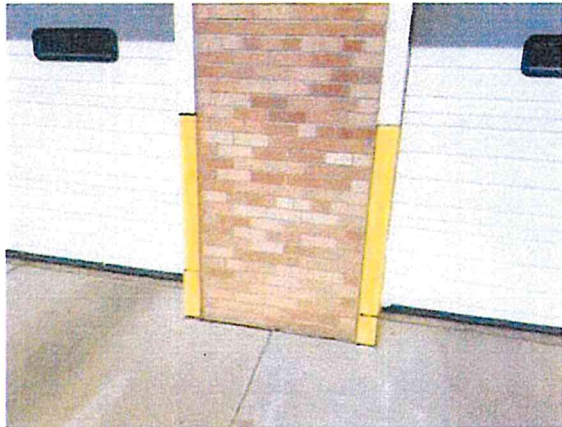
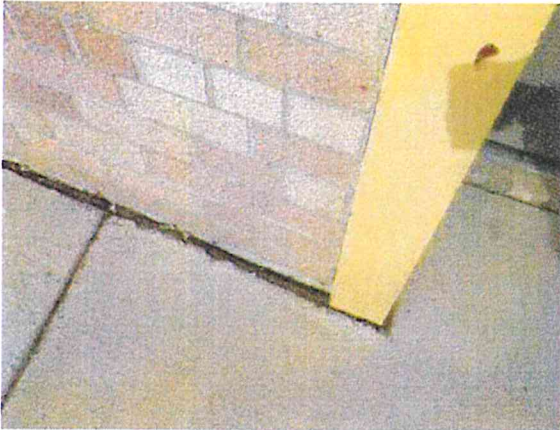
- (2) The steel angles at the apparatus door jambs are scraped and beginning to show signs of rust.
    - (3) The limestone surround at the west side of the center apparatus door is severely cracked and should be repaired to prevent further degradation.

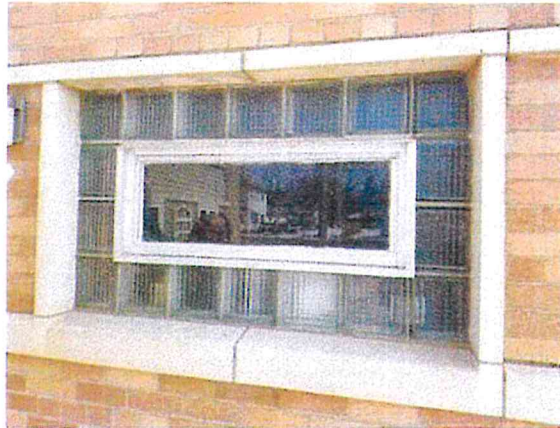
Figure D.2.4

4. The glass block window into the Boiler Room is in average condition.
    - (1) The limestone sill at the glass block window into the Boiler Room is missing mortar is cracked between the mortar and the limestone. This should be raked back 1/2" and filled with sealant.

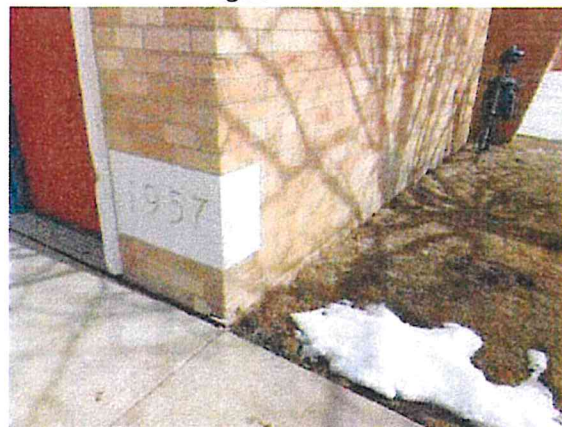
Figure D.2.5.1b

5. The exterior man door into the office is in good condition.
    - (1) The limestone surround at the man door into the Office is spalled in one section and is missing mortar at one joint and should be tuckpointed.

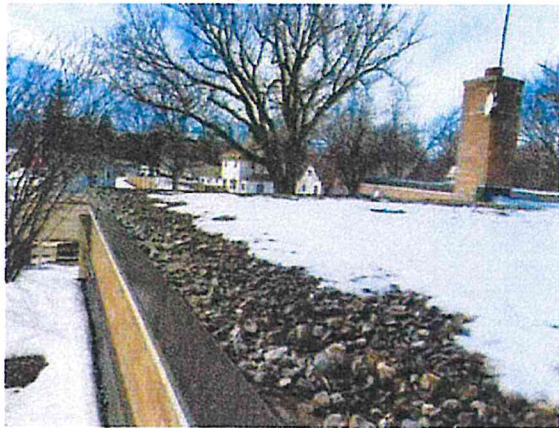
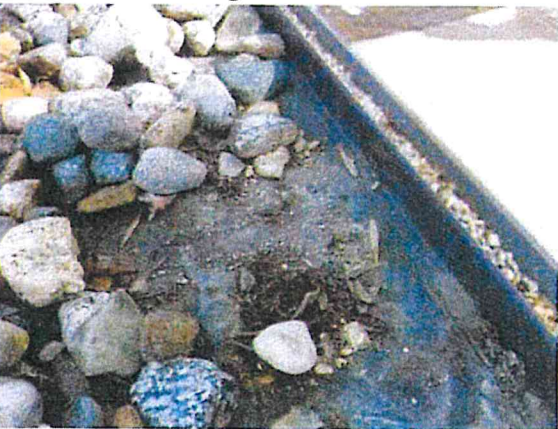
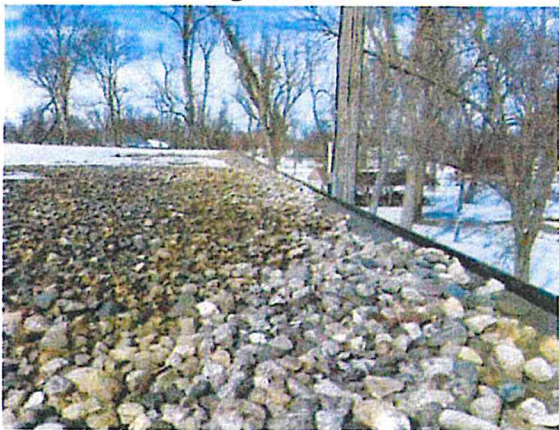
3. Roof
  1. The ballasted roof was installed in 2008 and is reported to be in good condition.
    - (1) The membrane shrank and pulled a portion of the apparatus bay parapet onto the roof. This was repaired under warranty.

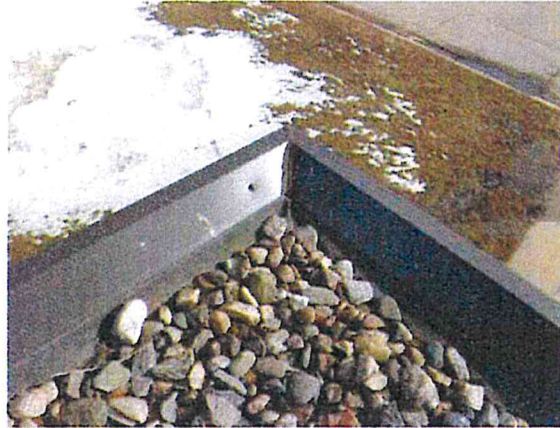
Figure D.3.2

2. The metal parapet caps and flashings are in excellent condition.
    - (1) We anticipate that sealants will need to be replaced within five years.
  3. The stucco soffit under the apparatus bay canopy is in good condition with some minor cracking.

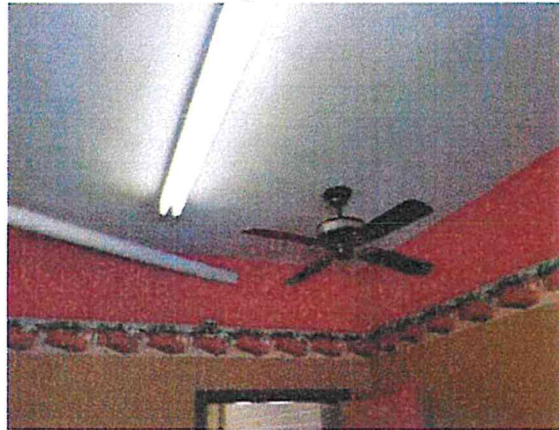
Figure E.4.1

2. The man door between the apparatus bays and the City Hall lobby is in good condition.
4. Ceilings
  1. The gypsum board ceiling in the Office is in good condition.

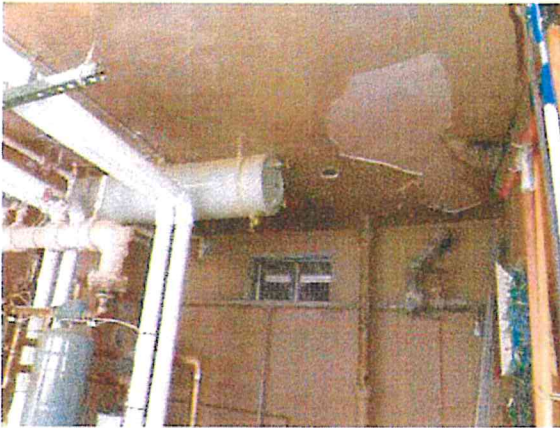
Figure E.4.2

2. The ceiling in the Boiler Room is in poor condition with portions of plaster loose around the roof drain.
5. Casework
  1. The wall cabinets in the Office are beyond their expected service life but are in good condition.

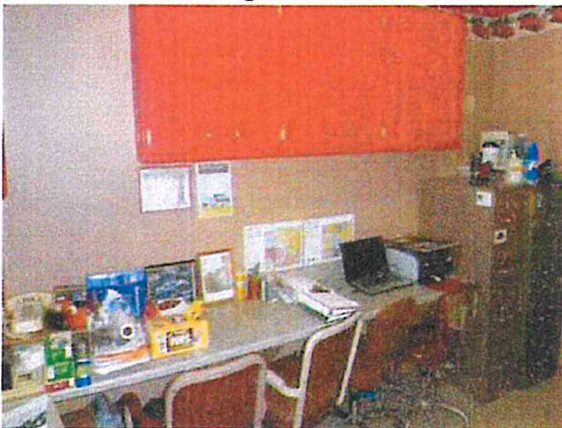
Figure E.5.2

2. The work counter in the Office is in good condition.
  3. The enclosed cabinets in the Apparatus Bay are in average condition.
  4. The open shelving in the Apparatus Bay is in poor condition with too much weight bending the shelves.

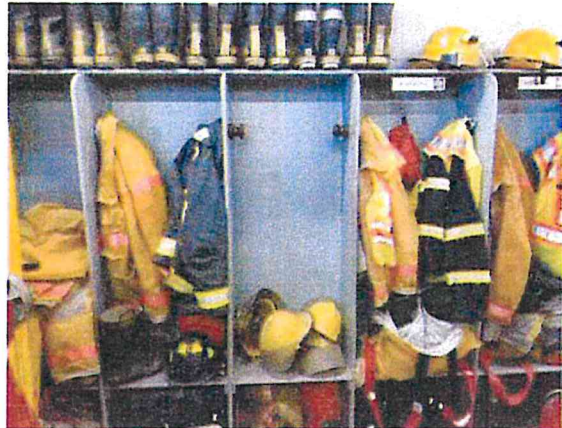
Figure E.5.5

5. The turnout gear lockers are in good condition.
  6. The counter and shelves at the radio storage area are in poor condition.
6. Equipment
  1. The ceiling fan in the office is in good condition.
