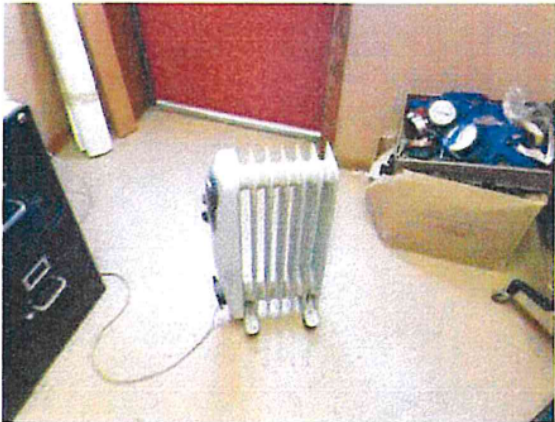
Figure I.2

1. The window air conditioner in the Office is past its expected service life and the cooling fins are bent. It should be replaced.
2. There is no heating system in the Office, and heat is provided by a plug-in radiator-type space heater.
3. There are two boilers in the Boiler Room, which were installed in 2016.
4. The water-side unit heaters in the apparatus bay are past their expected service life but are in good condition.
  1. The thermostat is located on the west wall of the Apparatus Bays
5. No ventilation or exhaust systems are installed in the Apparatus Bay.

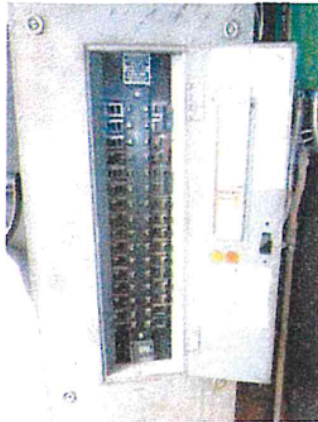
Figure J.2

1. A 200 Amp single-phase main panel and 200 Amp sub panel are located at the southeast corner of the apparatus bays.
  1. The main panel is missing a door.
2. An additional sub-panel is located in the Boiler Room.
3. The electrical panel and all circuit breakers appear to be in good working condition.
4. There is a junction box in the Office without a cover plate.
5. Electrical shore lines at each apparatus are powered through 12V converters or car battery chargers.
6. Outlets in the Apparatus Bays appear to be without Ground Fault Interrupt

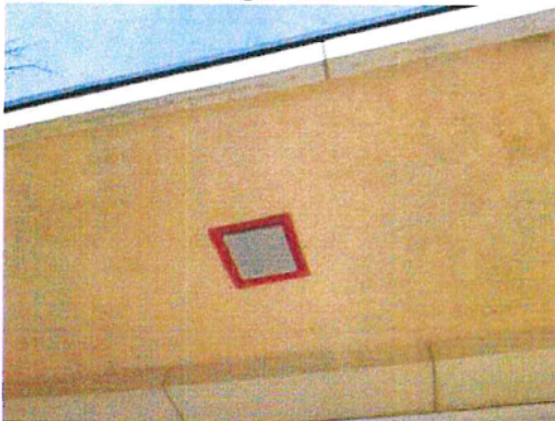
Figure L.1.1

1. Exterior
  1. The soffit-mounted lighting above the bay doors are in average condition.
  2. The Office and Boiler Room doors have adjacent wall sconces.
    - (1) The sconce by the Office man door is missing a light bulb and globe.
2. Interior
  1. Lighting in the Apparatus Bays consists of surface-mounted four-foot strip fluorescent fixtures.
  2. The lighting in the Office is a surface-mounted eight-foot strip fluorescent fixture.
  3. The lighting in the Boiler Room is two surface-mounted four-foot strip fluorescent fixtures.
  4. All interior lighting control consists of line voltage toggle switches.

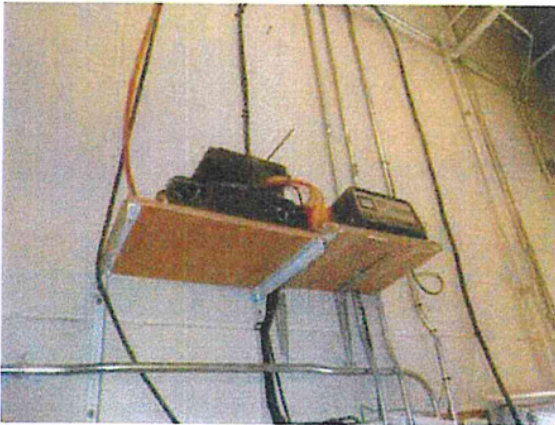
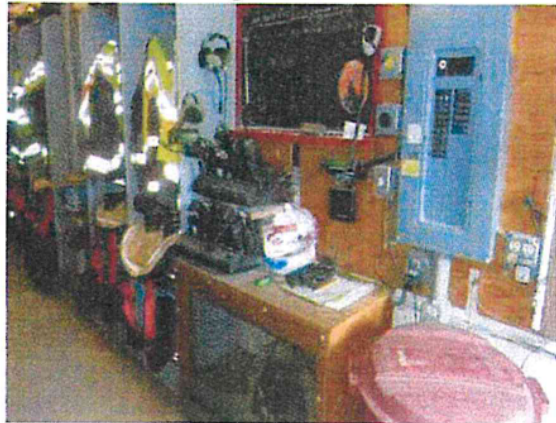
Figure M.1.1a

1. Telephone/Data
  1. A CB Radio system is located at the southeast corner of the apparatus bay.
  2. A telephone patch panel is located at the southeast corner of the apparatus bays.
2. Fire alarm
  1. There was no fire alarm system (horns, strobes, etc.) observed in the building.
