# Fulda Fire Department Study

Fulda, Minnesota

July 2, 2018

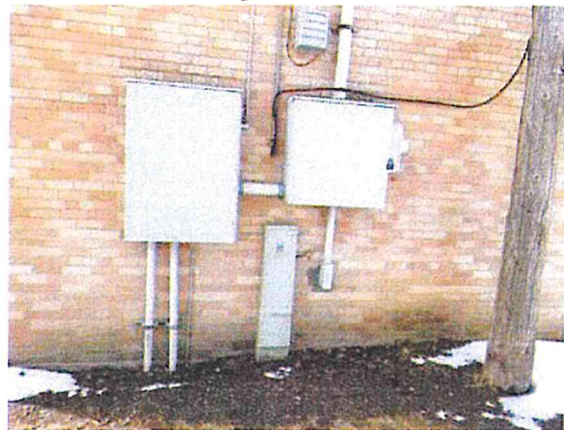
Figure B.10.1

1. Communications comes both overhead and below grade to the southeast corner of the building.
  2. There is a pole-mounted radio antenna at the southeast corner of the building.

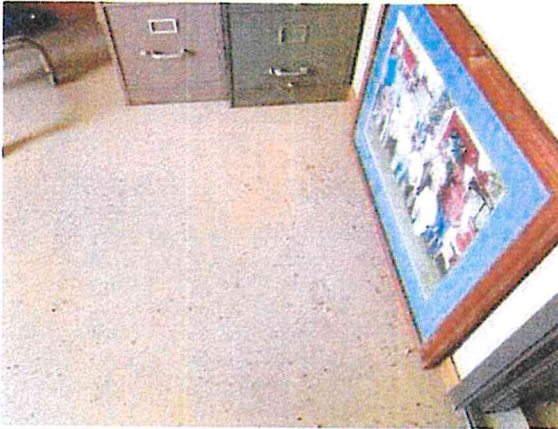
Figure E.1.1

1. Flooring
  1. The epoxy flooring in the office is in average condition with bleed-through from imperfections in the concrete slab-on-grade.
2. Walls
  1. The cement block walls in the Apparatus Bay are in generally good condition.
    - (1) There is vertical cracking in the non-bearing wall where the roof drain runs down the exterior wall.
    - (2) There is significant horizontal cracking where the ceiling joists pass through the wall separating the City Hall storage room from the Apparatus Bay. This is caused by normal building movement like the deflection of the roof structure under heavy snow loads.
  2. The gypsum board walls in the office are in good condition.
3. Doors and Windows
  1. The man door between the apparatus bays and the office is in good condition.
    - (1) The smoke seals are in good condition.

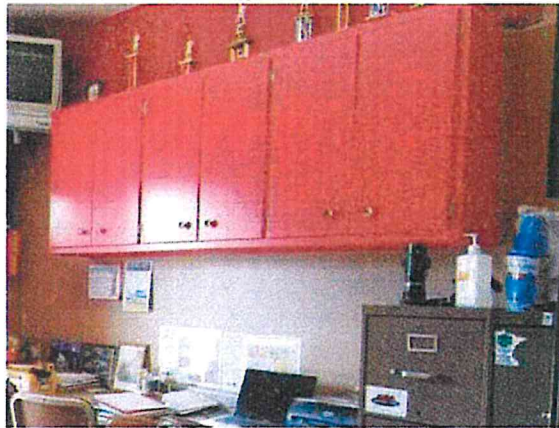
Figure E.5.1

2. The ceiling in the Boiler Room is in poor condition with portions of plaster loose around the roof drain.
5. Casework
  1. The wall cabinets in the Office are beyond their expected service life but are in good condition.

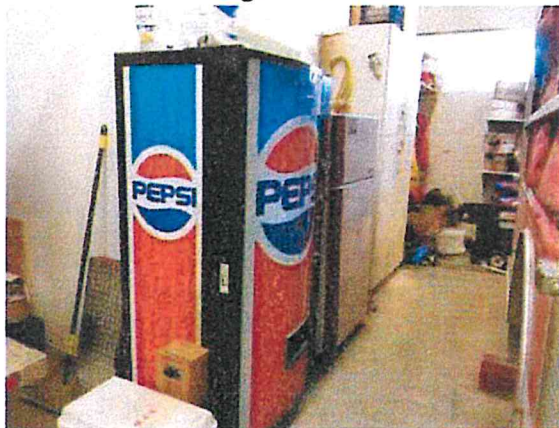
Figure E.5.3

2. The work counter in the Office is in good condition.
  3. The enclosed cabinets in the Apparatus Bay are in average condition.
  4. The open shelving in the Apparatus Bay is in poor condition with too much weight bending the shelves.

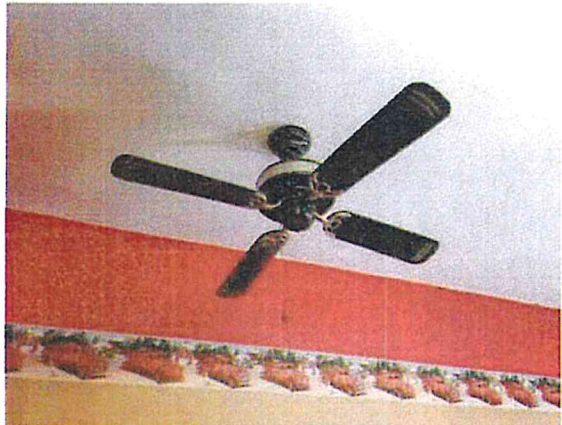
Figure E.6.1

5. The turnout gear lockers are in good condition.
  6. The counter and shelves at the radio storage area are in poor condition.
6. Equipment
  1. The ceiling fan in the office is in good condition.

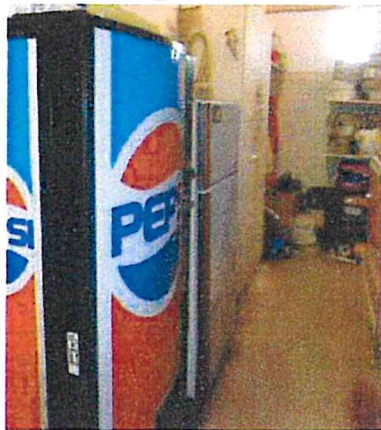
Figure E.6.2

2. The Pepsi machine appears to be in good condition.
  3. The refrigerator in the Apparatus Bay is in poor condition.
  4. The drawbar-type overhead door openers are in good condition.

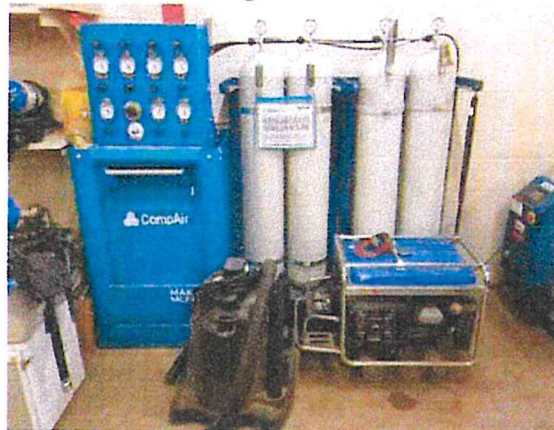
Figure E.6.5

5. The Mako SCBA cascade and fill station is in good condition.
  6. The Bauer SCBA compressor is in good condition and has an exterior air intake.

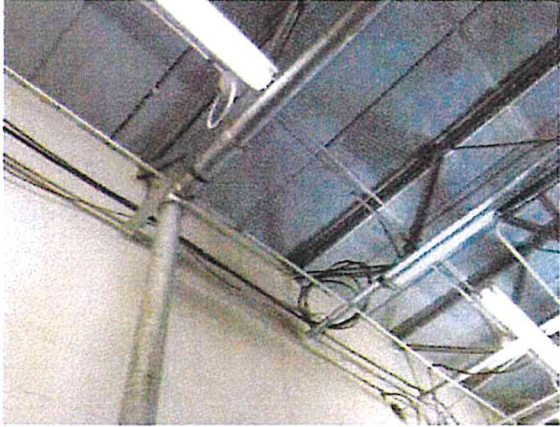
Figure H.1.1a

1. Domestic Water
  1. The cold water pipe crosses the apparatus bay above the trucks for tank-fill then enters the boiler room.
  2. A 34 kBTU 40-gallon gas fired water heater is installed in the Boiler Room
2. Sanitary Sewer
  1. The sanitary sewer system was not observed.
3. Compressed Air
  1. A 60-gallon air compressor is located in the boiler room and is in good condition.

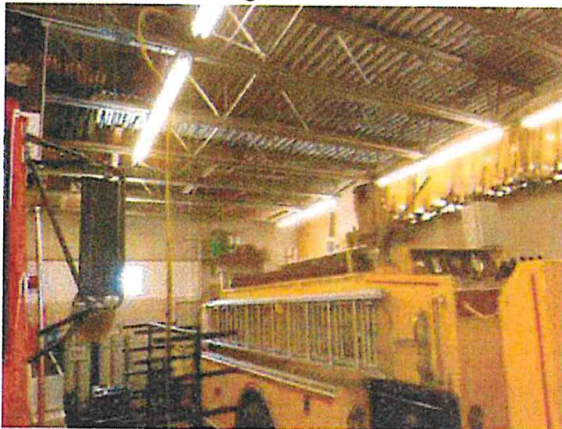
Figure H.3.2

2. Compressed air piping consists of 3/4" PVC routed from the air compressor overhead to drops at each apparatus with air brakes.
4. Fixtures
  1. There is one floor drain in the Boiler Room.
  2. There are hot and cold hose bibbs in the Apparatus Bay.
  3. There is one catch basin in the Apparatus Bay floor.
